Georges Lemmen (1865-1916)

The Cliffs of Dover (Les falaises de Douvres)

1892 signed bottom right, monogram "GL" undated Oil on canvas h 16.5 x b 24.2 cm WRM Dep. FC 766

Brief Report

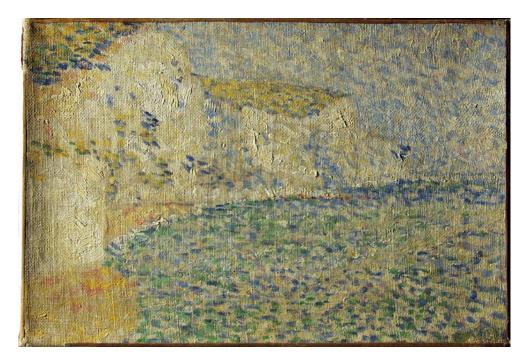
Fig. 3
Raking light, on the right-hand edge a broad stretchmark can be seen; it does not correlate with the present stretching points, and dates back to the stretching of the length of canvas for prepriming in the factory, prior to cutting

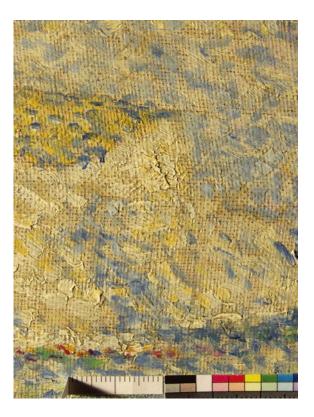
Authenticity/Condition	varnished, not authentic; the present coat is superimposed on a
	paint layer much reduced by the removal of an earlier coat of varnish;
	remains of a browned coat of varnish still discernible in the area of
	the signature (fig. 9)

Fig. 9 Detail under raking light, area of the chalk cliff with ground left visible

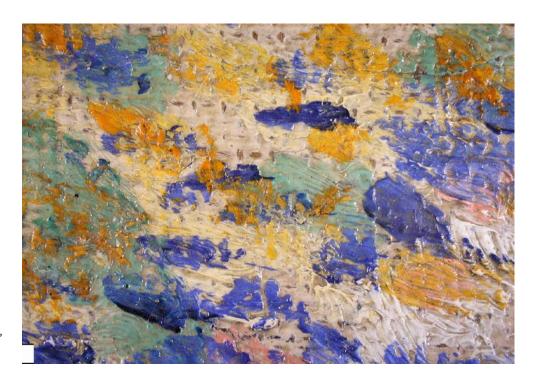
Many areas are executed wet-in-wet, testifying to the brisk progress of the work. The pale ground plays a part in many areas of the picture and evokes the filmy character of the picture (fig. 9). Unfortunately a lining operation along with an inexpert varnish removal have impaired the pristine delicacy of the colour effect (figs. 10-12).

Fig. 10
Abbed paint application, microscopic photograph (M = 1 mm)

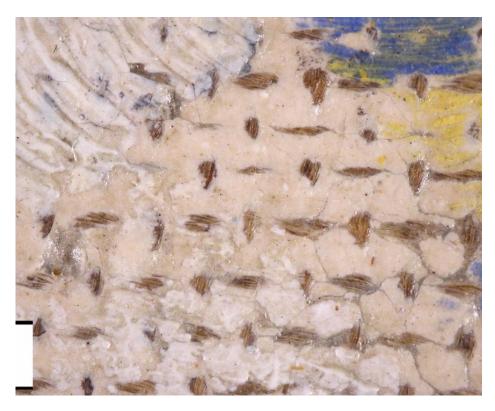
Fig. 11

Lined, whereby the original fold-over edge was cut off all round; linear broken and repaired areas of the paint layer are due to folds or creases in the original picture support; serious abrasion both of the paint layer and in the ground where this was not covered with paint, in particular on the high points of the canvas weave; brushwork has been levelled off in many paces, impasto applications have been squashed (figs. 11,12).

Abraded paint layer and ground, the high points of the weave are visible, microscopic photograph (M = 1 mm)

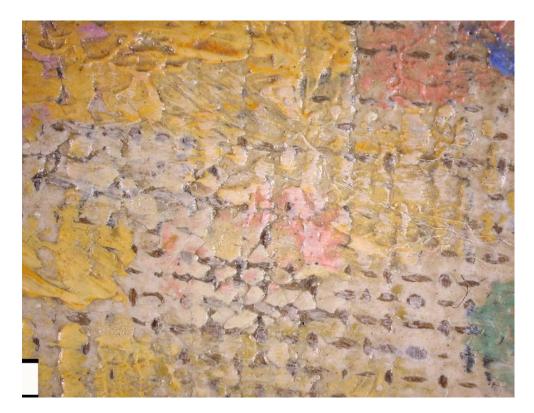
Fig. 12

Damaged surface due to lining and incompetent removal of varnish, microscopic photograph (M = 1 mm)
