Georges Lemmen (1865-1916)

The Cliffs of Dover (Les falaises de Douvres)

1892 signed bottom right, monogram "GL" undated Oil on canvas h 16.5 x b 24.2 cm WRM Dep. FC 766

Brief Report

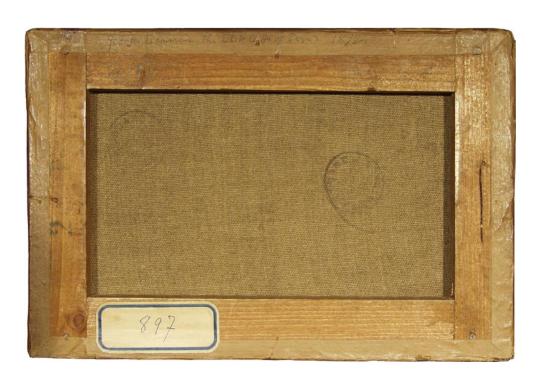
Fig. 2 Verso, lined

Lined, whereby the original fold-over edge was cut off all round; linear broken and repaired areas of the paint layer are due to folds or creases in the original picture support; serious abrasion both of the paint layer and in the ground where this was not covered with paint, in particular on the high points of the canvas weave; brushwork has been levelled off in many paces, impasto applications have been squashed (figs. 11,12).

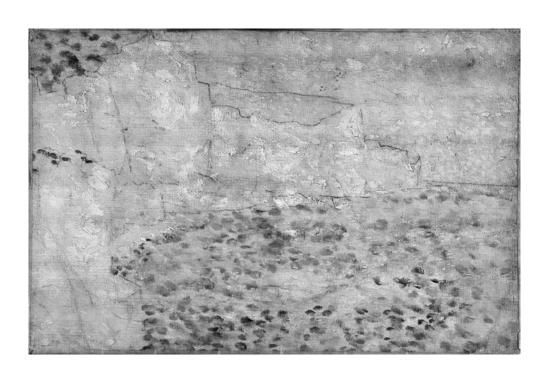
Fig. 5 IR reflectogram

Medium/technique	presumably lead or graphite pencil, linear, very fine lines
Extent/character	sparse outlines with little internal structure (figs. 5, 6)
Pentimenti	_

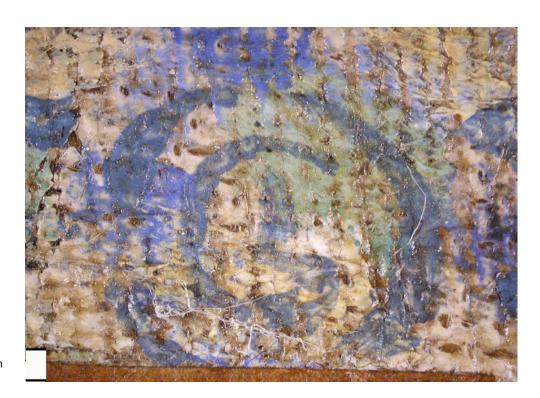
Fig. 6
Signature monogram,
microscopic photograph
(M = 1 mm)

Signature/Mark	
When?	at the same time as the picture was painted
Autograph signature	"GL" as monogram framed in a circle (fig. 6) in the bottom right-hand corner; diameter of circle c. 0.9 cm, all in a blue identical with the blue in the painting
Serial	_
Frame	
Authenticity	not original

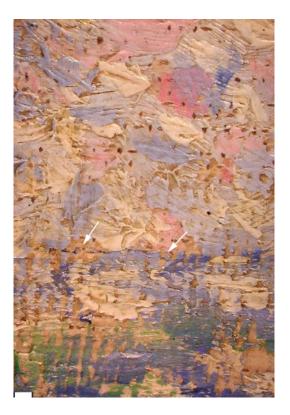
Fig. 7 Visible horizon in the underdrawing beneath the paint layer (arrow), microscopic photograph (M = 1 mm)

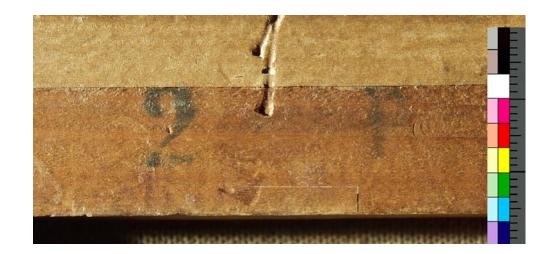
Picture support canvas	
Standard format	P2 horizontal (24.0 x 16.0 cm), format stamp 2 P in blue ink on the left-hand stretcher bar (fig. 8)
Weave	tabby weave
Canvas characteristics	very fine, loosely woven canvas; 14 x 15 threads per cm vertical and horizontal; Z-twist
Stretching	cut to size precisely along threads; present stretching has produced no stretchmarks; the conspicuous widely separated stretchmarks on the right-hand side derive from the stretching of the long length of fabric prior to pre-priming in the factory, i.e. the small format was evidently cut from the edge of a large piece of prepared canvas (fig. 3)
Stretcher/strainer	stretcher, presumably original
Stretcher/strainer depth	1.0 cm
Traces left by manufacture/processing	Traces left by manufacture/processing: mortise-and-tenon con- struction, fastened with an iron nail at each corner; traces of use of marking gauge; bevelling of inner edge by 4 mm

Fig. 8
Detail, format stamp
"2P" on the left-hand
stretcher bar
